Service Bulletin

Customer	All	S.B. No	
		Issue	2
Title	PR18 Skip Loader– Product information. Suspension pin method of inspection Part number S1001-LC-505	Job No.	
		Date	22/07/2021
		Raised by	John Jennings

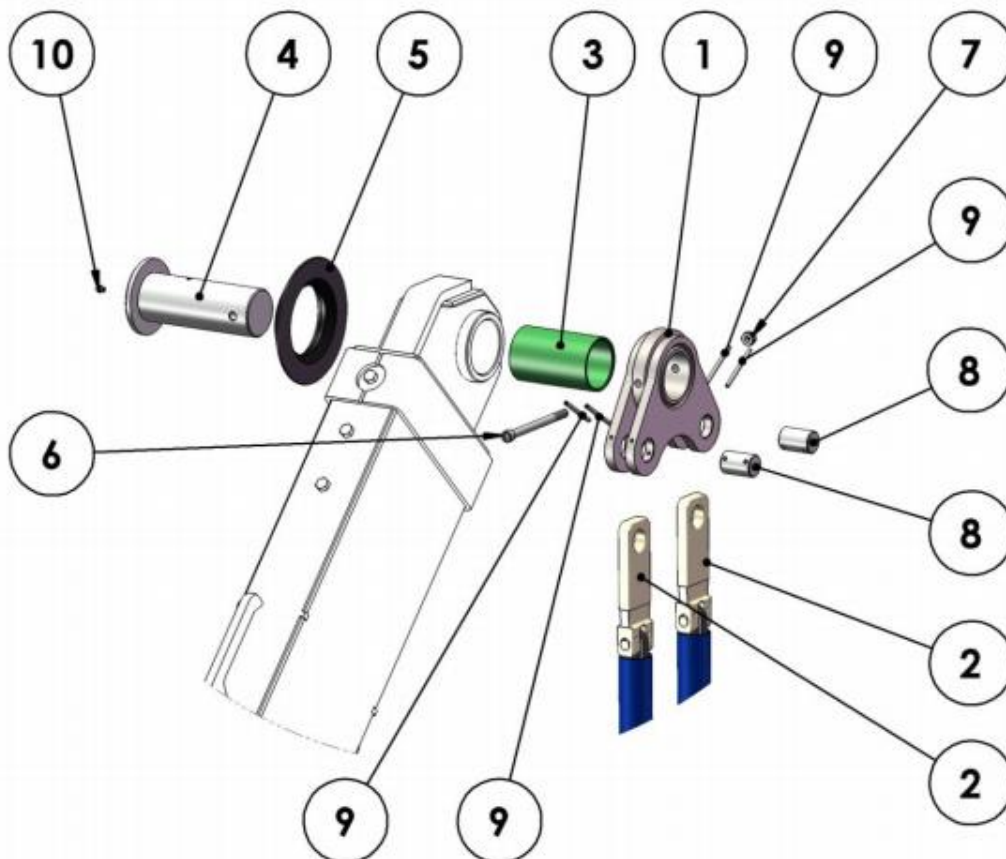
Figure 1 -Chain assembly version 2 fitted from 2016 onwards

Early investigations carried out around this reported failure have identified that damage to one or more of the two main saddle assemblies (figure 1 item 1) occurred. The saddles that have failed have been returned and found to have distorted side plates due to incorrect operation. The distortion to the side plate of the saddle has consequently broken both the securing roll pins (figure 1 item 9) leaving the suspension pin (figure 1 item 8) free to move in the saddle (Figure 1 item 1).

The reason identified for the saddle distortion is due to side loading through the suspension plate created when a skip is lifted without all four chains attached to the container lifting lugs.

Parts found to be distorted and damaged must be replaced by a qualified technician.

- Item 1 – S1001-LC-946 – Chain Saddle.
- Item 8 - S1001-LC-505 – Chain Suspension pin
- Item 9 - SLOTTED SPRING PIN 6X80 PLAIN

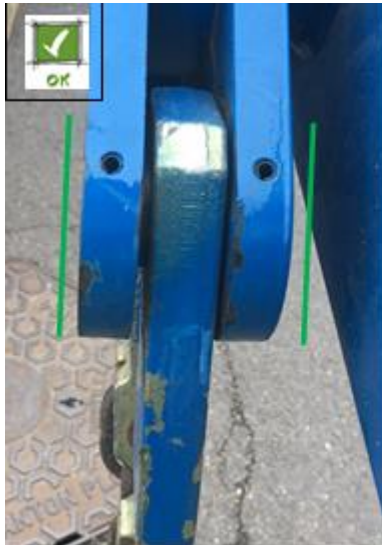
Figure 3 & 6 where the suspension pin is flush with the saddle side plates is serviceable.

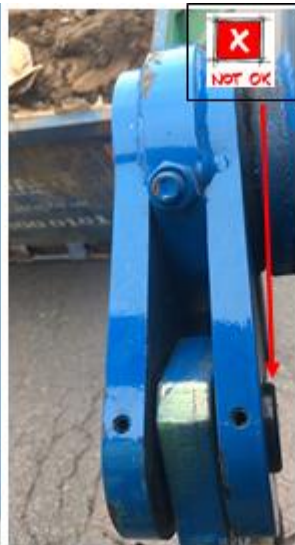
Figure 4 & 5 Where the pin is outward or inward or not flush with saddle plates is not serviceable and it must be replaced.
